FLOODS OF JUNE 1965

SOUTH PLATTE RIVER BASIN,
COLORADO AND NEBRASKA

U. S. ARMY ENGINEER DISTRICT, OMAHA
CORPS OF ENGINEERS
OMAHA, NEBRASKA
JANUARY 1967

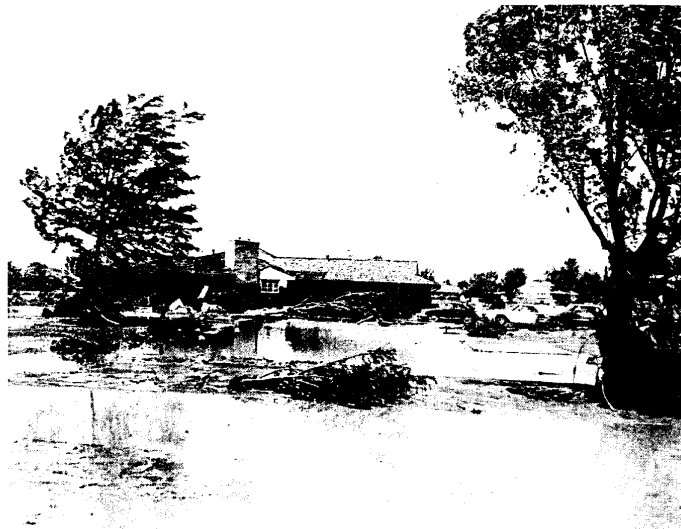
#1 Destruction of highways and bridges due to flooding and bank erosion at Castle Rock on East Plum Creek.

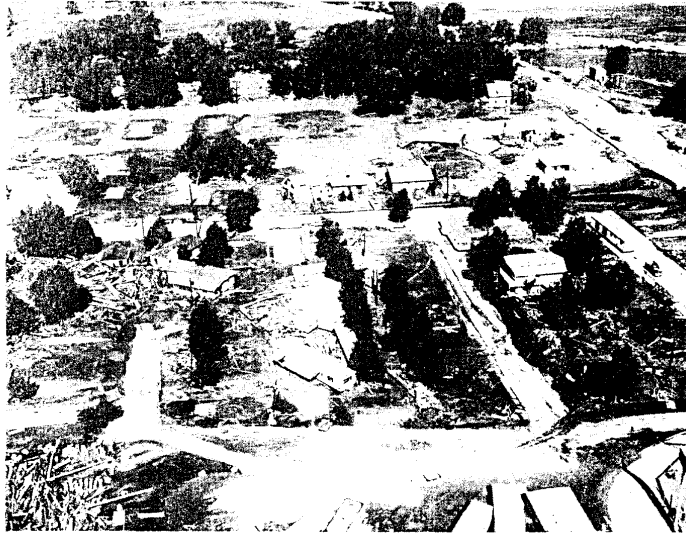
#2 Columbine Country Club area in southern part of metropolitan Denver. Two homes were washed from foundations shown in foreground and house shown was extensively damaged. Rear walls were destroyed and furniture was carried away. Note highwater mark on house.

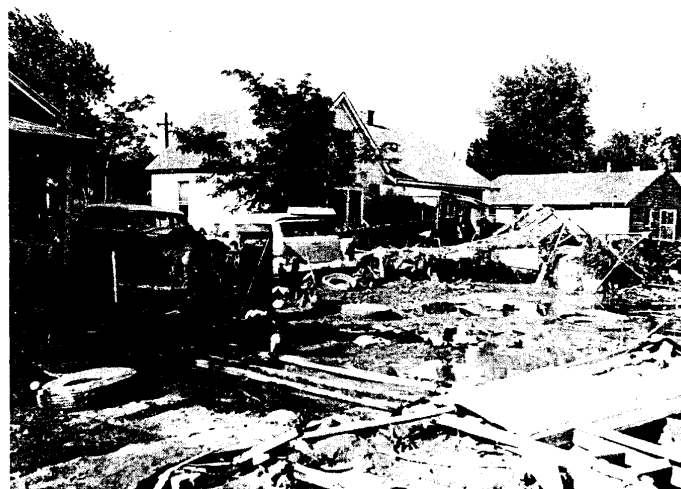
#9 View of house washed from foundation and left on top of cars upstream of Alameda Avenue in Denver proper. Note highwater mark on house.

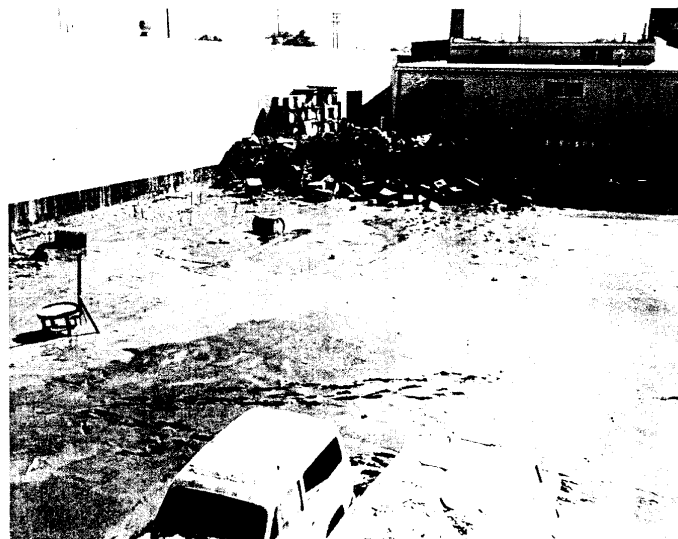
#11 View of debris lodged at 13th Avenue bridge in Denver proper. Truck can be seen in center photograph.

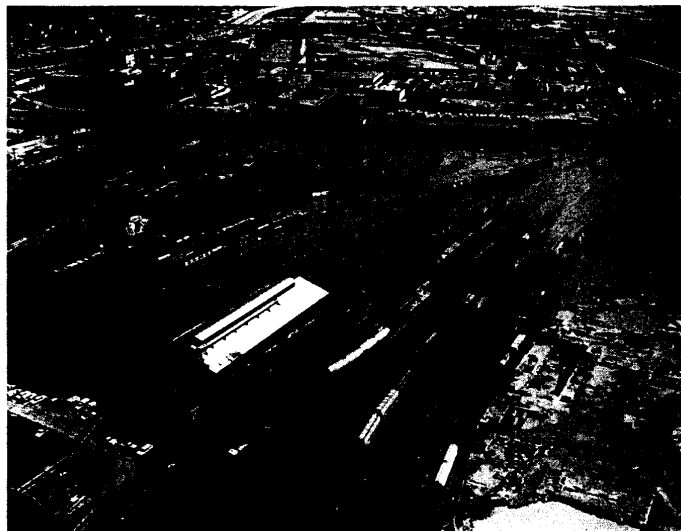
#12 Damage and debris at paint warehouse on left bank of South Platte River between 8th and 9th Streets in Denver proper. Note highwater marks on warehouse and over top of cars.

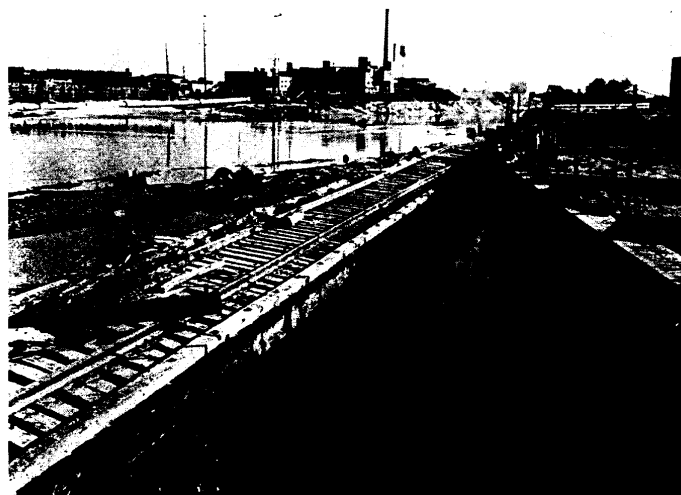
#13 View of flood damage in Colorado and Southern Railroad yards showing cars overturned and askew of tracks. Yards are on right bank across from area shown in photograph #12.

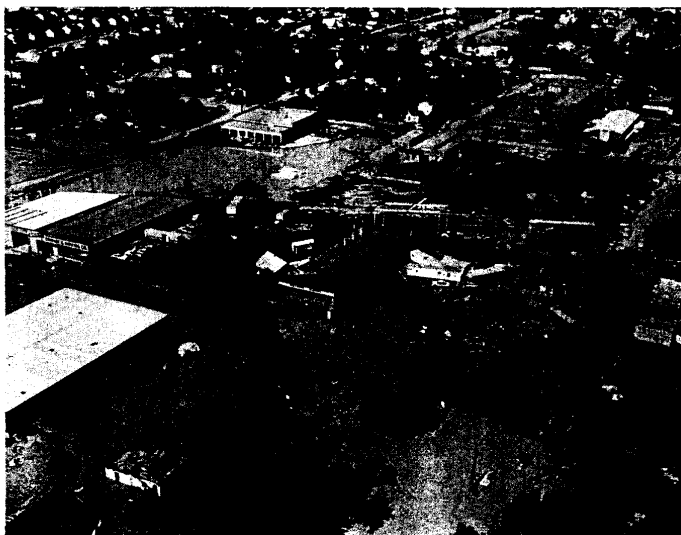
#19 Photo showing section of Littletons' business district in lower left hand corner. The destructive force of the flood is clearly illustrated.
